## Existing Old Gymnasium

**SVA Architects, Inc.**

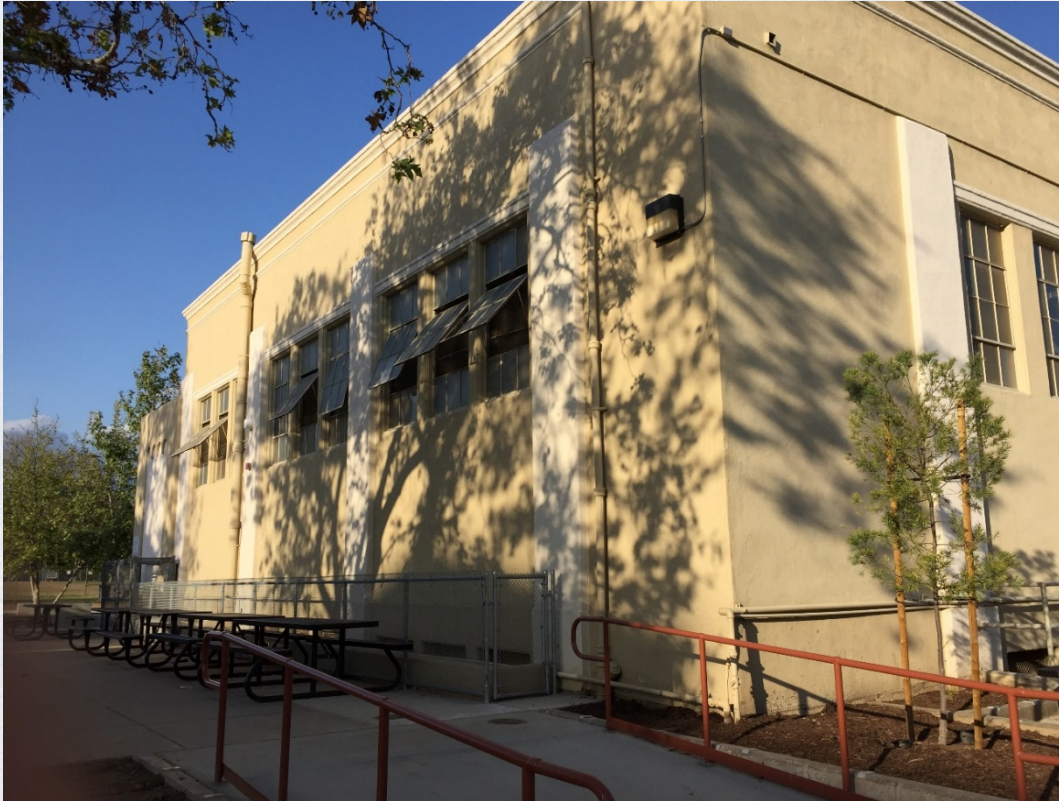
*Constructed in 1928, the old gym is split level two-story concrete structure (one level partially below grade) with a truss roof structure (previously damaged in a fire and repaired).*

*The building is surrounded by the existing courtyard to the west and south, a SoCal Edison easement to the east (limiting any new construction that side of the building) and the end of Rollin St. to the north.*

*The building was analyzed for historical significance as part of the 2004 EIR performed by the district for the Middle School campus expansion. This analysis found that the building was **potentially eligible** for local historical registry per City criteria, but not state or national. The building is **not** currently on the local historical register.*
